CLEAR PATH HOME INSPECTIONS REPORT 7-6.1

1137 Paseo de Suerte Dr
Horizon City, TX 79928

PROPERTY INSPECTION REPORT FORM

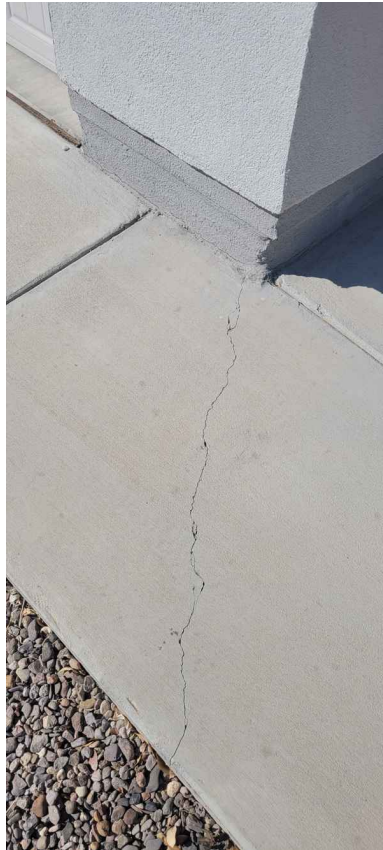
Minor cracking was noted at the foundation. This is common as concrete ages. Shrinkage surface cracks are normal. Recommend monitoring for more serious shifting/displacement.

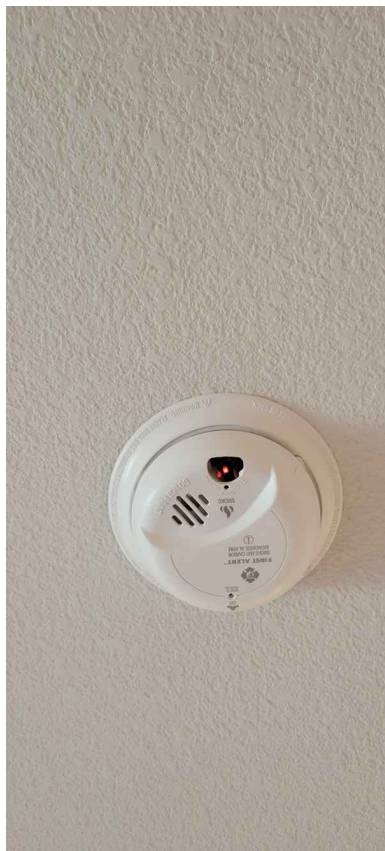
One or more smoke alarms has damage and needs to be replaced

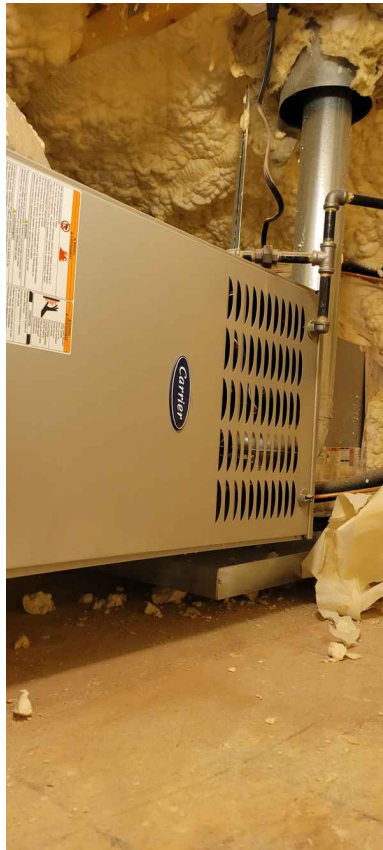
Clean & Service Prior to Closing:

It is recommended to have the heating unit cleaned and serviced by a licensed & qualified HVAC technician. The observations made to support the rendering of this opinion are listed but may not be limited to the following:

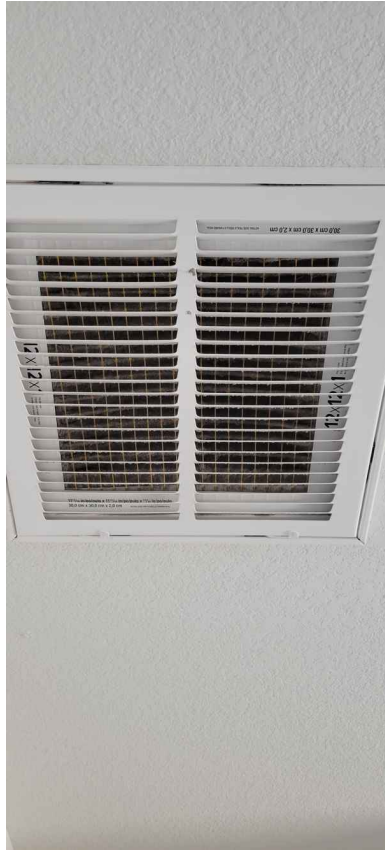
The air filter(s) was dirty. I recommend replacement ASAP. This puts additional strain on the air handler, can shorten the life of the unit, and affects the efficiency of the unit.

Recommendation: Recommended DIY Project

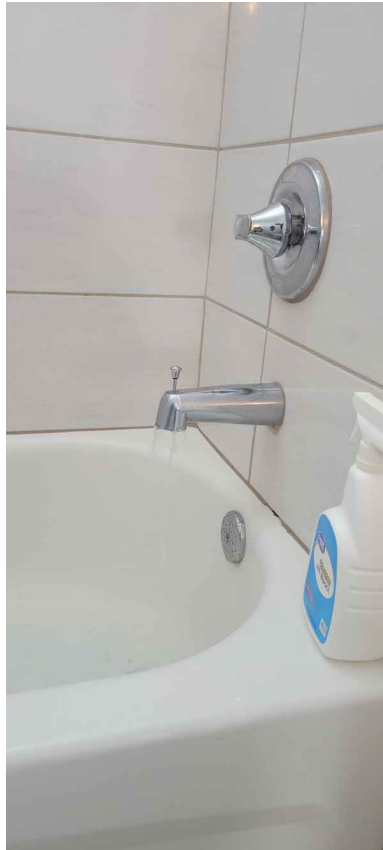
The shower diverted is not operating properly at the time of inspection. We recommend cleaning diverter or replacement so that the shower operates as intended.

Recommendation: Contact a qualified plumbing contractor.

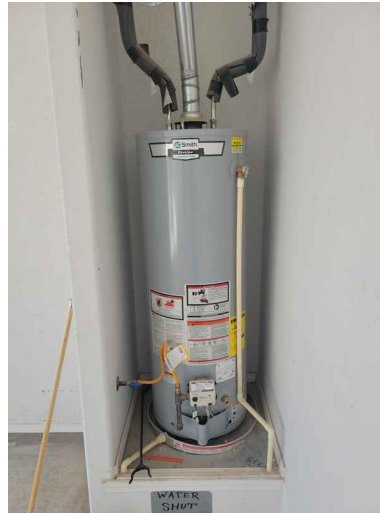
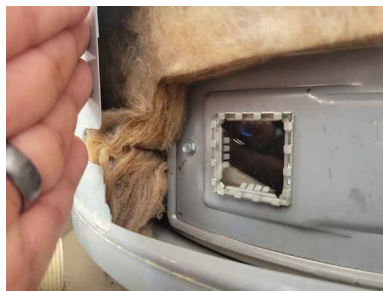
Brand: AO Smith

Approximate Year Built: 2020

Energy Source: Gas

Gallon Capacity: 40 Gallons

Expansion Tank Applied: No

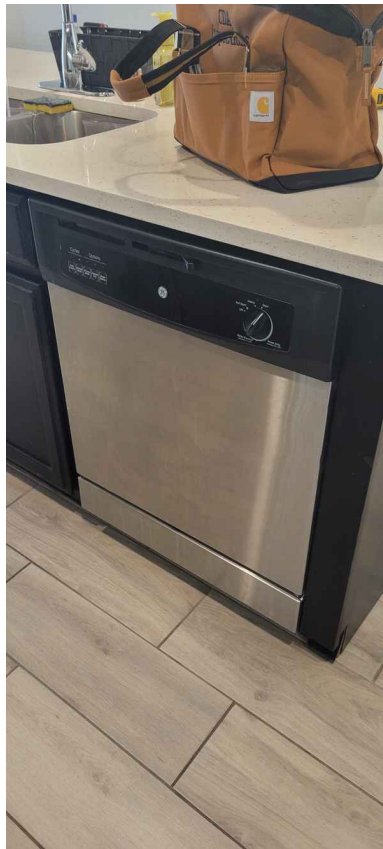
Dishwasher Operational:

The dishwasher was operated by running a wash cycle and was functional at the time of inspection. No leaks or water was present at the base of the unit at the completion of the cycle. The unit's efficiency of cleaning dishes is not tested. No deficiencies were observed with the unit unless otherwise noted in this report.

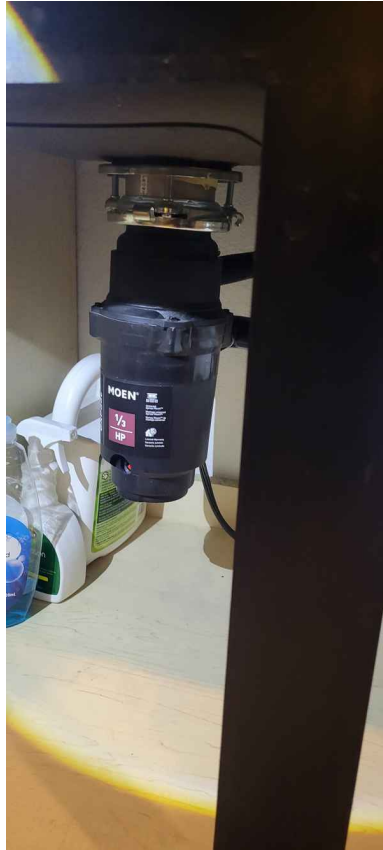
Food Waste Disposer Operational:

The food waste disposal was inspected to determine it was functional while also looking for leaks from the unit, an exposed power cord, heavy rust, or other deficiencies. No reportable conditions were present at the time of inspection unless otherwise noted in this report.

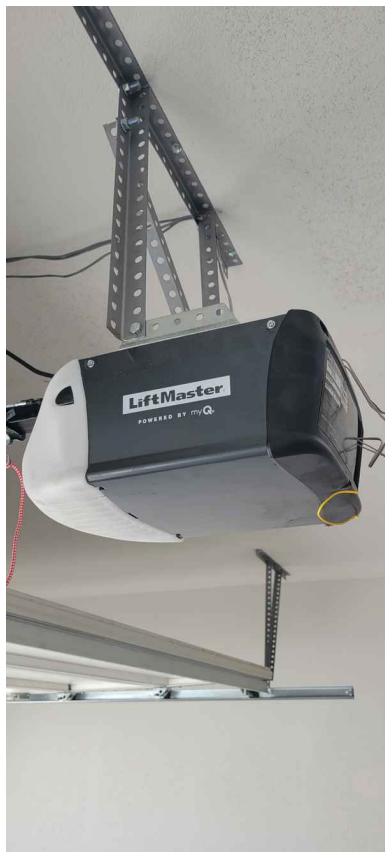
Garage Door Operator(s) was/were operating:

The garage door operator(s) were tested by operating the wall-mounted transmitter and checking for proper operation. The door(s) were examined for significant damage or installation-related deficiencies. No reportable conditions were present at the time of inspection unless otherwise noted in this report.

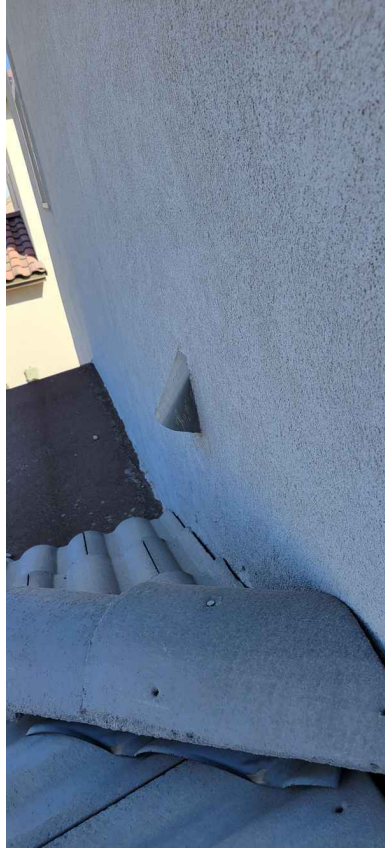
Dryer Vent should be cleaned annually:

The dryer vent should be **cleaned** at least annually if not more frequently. Cleaning your dryer vent piping will allow the dryer to vent properly and work more efficiently. Dryer vents that are not cleaned regularly can be a fire hazard
